EMBANKMENT CRITERIA AND PERFORMANCE REPORT

FALL RIVER BASIN

COLD BROOK LAKE, SOUTH DAKOTA

Omaha District

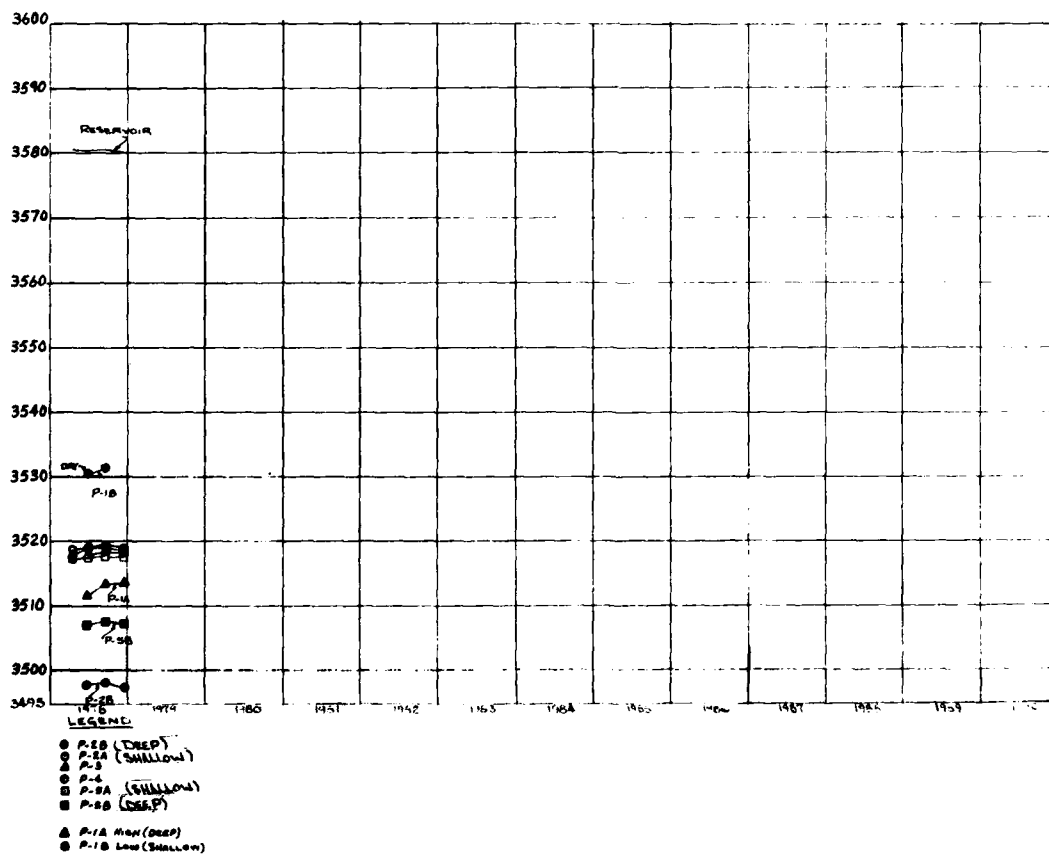
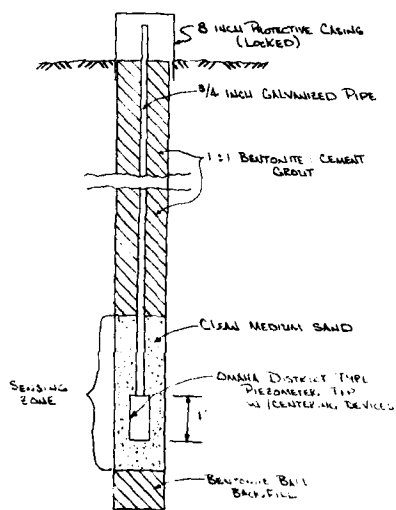
LOCATION PLAN

5.6. Piezometers. Plate 22 shows the location of the eight piezometers at this project. Also shown on this plate is a typical installation detail and a plot of the piezometric readings to date. Three of the piezometers (deep) monitor water levels in the sandstone bedrock. The other five piezometer (shallow) monitor water levels in the foundation alluvium. The readings to date show that there are no significant pressures under the embankment. This indicates that the foundation cutoff is effective for pool levels up to elevation 3585.
